Re: Provincial Designation Nomination for 2124 Elphinstone Street

## PROVINCIAL HERITAGE PROPERTY DESIGNATION NOMINATION FORM

Name of Property: Ecole Connaught Community School

## INITIAL HERITAGE ASSESSMENT

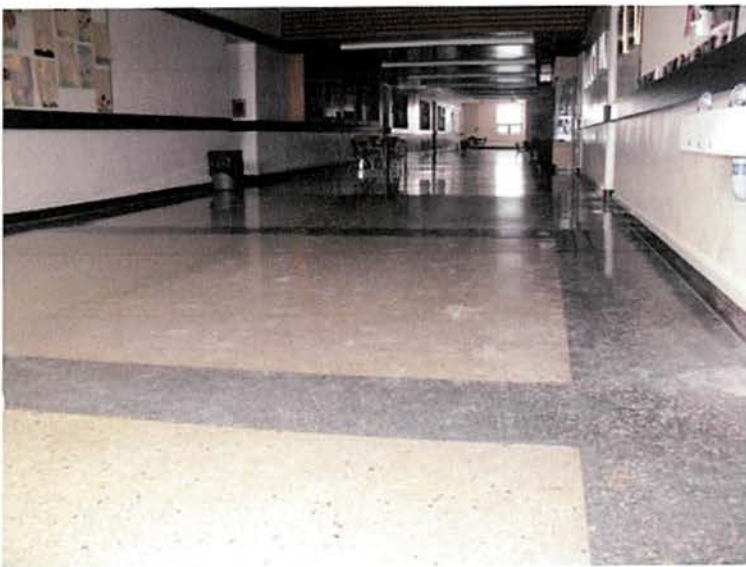
Rounded plaster corners.

The columns and floor slabs are reinforced concrete. Puntin (1915) described his interior treatment as "ornately simple" (p. 42). Interior walls feature rounded plaster corners (Yardley, 2012). Corridors and stair landings are marble terrazzo, laid in a decorative panel effect to prevent cracking (Puntin, 1915). The hallway

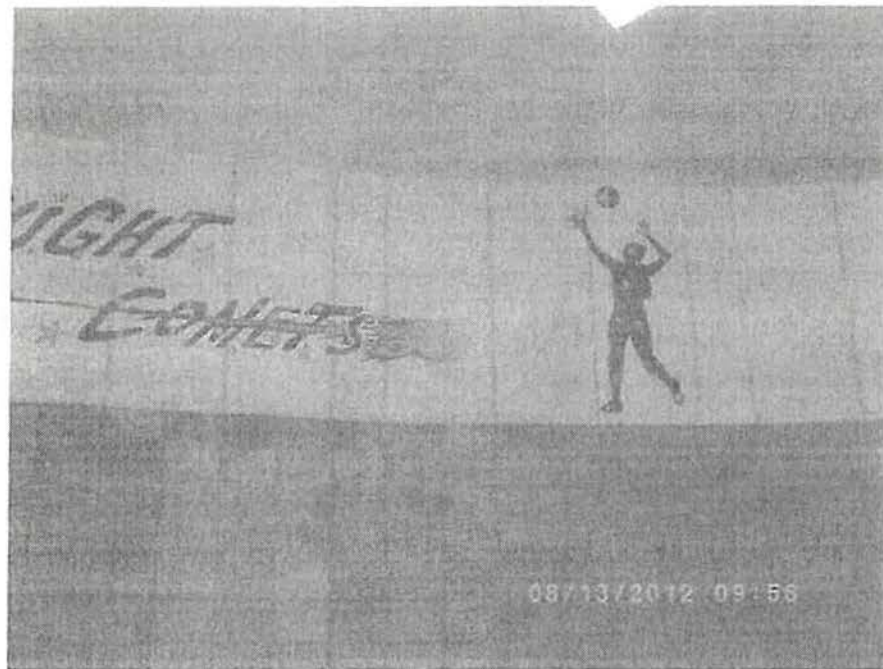
Photo 1: Water Stains in the Gymnasium

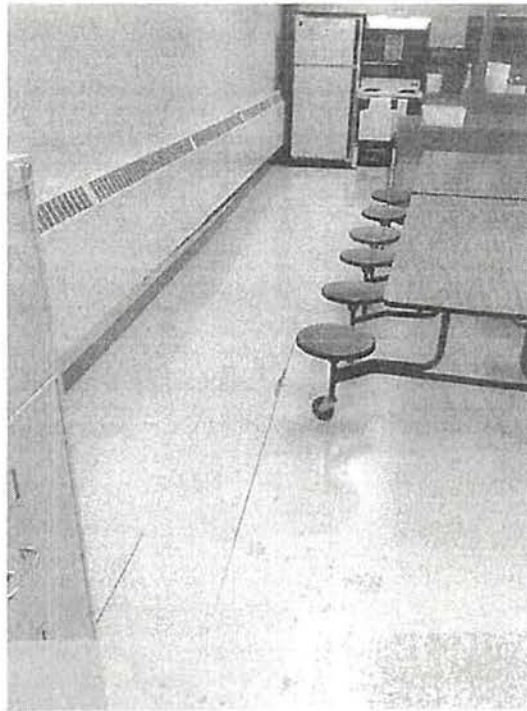
Photo 1: Nutrition Room- Cracks in tile at floor heave location

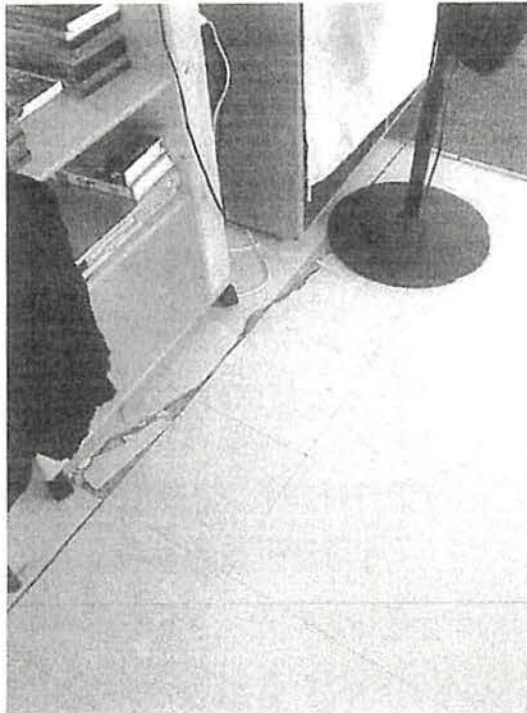
Photo 2: Wise Owl Daycare- Cracks in concrete at heave location

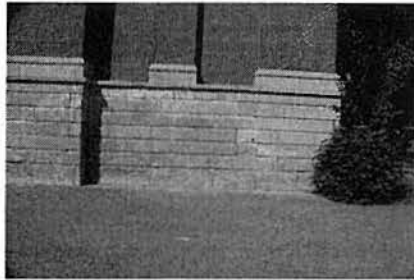
The cornice was removed for unknown reasons allowing water penetration into a soft clay brick face that was meant to be protected by the cornice. The pointing mortar in this area has deteriorated or is missing due to this exposure. The cornice could be easily reinstated and the parapet repointed. The lower limestone sections if deterioration was caused by completely inappropriate interventions. The soft Indiana Limestone was pressure washed forcing water into the porous stone which in turn caused the efflorescence present on the exterior of the building face. Also the pressure washing removed the protective patina on the stone causing spauling. The wand marks from the pressure washing are still clearly visible. This intervention was supposedly done to remove graffiti but instead has caused substantial damage.

The lower limestone sections' deterioration was caused by completely inappropriate interventions. The soft Indiana Limestone was pressure washed forcing water into the porous stone, which in turn caused the efflorescence present on the exterior of the building face.

Also the pressure washing removed the protective patina on the stone, causing spauling. The wand marks from the pressure washing are still clearly visible. This intervention was supposedly done to remove graffiti but instead has caused substantial damage.
