Application for Municipal Heritage Designation

Lot(s): _____ Block: 394 Plan No: DV4420 Subdivision: Ext 3Address: 2124 Elphinstone Street, Regina

CONNAUGHT SCHOOL 2124 ELPHINSTONE STREET REGINA SK

INITIAL HERITAGE ASSESSMENT

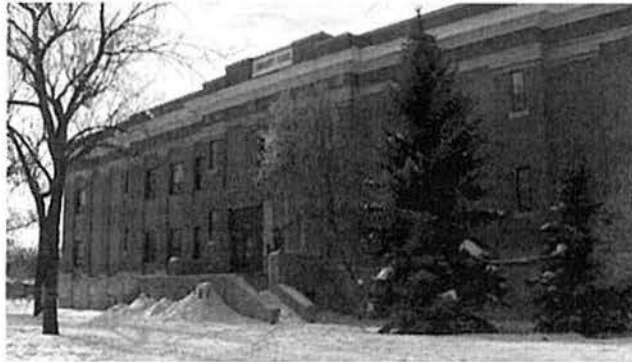
This was Connaught circa 1912 and as it appears today. A poor example of its former glory. Windows have been bricked over limiting the amount of sunlight and fresh air which instead is now controlled through mechanical and electrical systems. This is completely contrary to the original design of the architect who so carefully took into consideration the orientation and placement of the school. The portico over the front entrance has been removed exposing the stairway to water penetration and environmental deterioration. This shows a complete lack of understanding between design elements, form and function.

The portico over the front entrance has been removed, exposing the stairway to water penetration and environmental deterioration. This shows a complete lack of understanding between design elements, form and function.

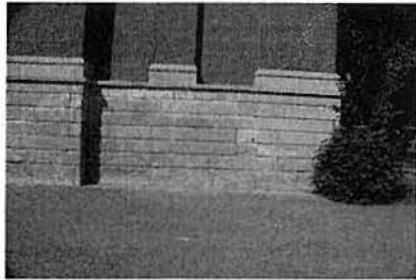
Exterior Masonry Condition

The cornice was removed for unknown reasons allowing water penetration into a soft clay brick face that was meant to be protected by the cornice. The pointing mortar in this area has deteriorated or is missing due to this exposure. The cornice could be easily reinstated and the parapet repointed. The lower limestone sections if deterioration was caused by completely inappropriate interventions. The soft Indiana Limestone was pressure washed forcing water into the porous stone which in turn caused the efflorescence present on the exterior of the building face. Also the pressure washing removed the protective patina on the stone causing spalling. The wand marks from the pressure washing are still clearly visible. This intervention was supposedly done to remove graffiti but instead has caused substantial damage.

The pointing mortar in this area has deteriorated or is missing due to this exposure. The cornice could be easily reinstated and the parapet repointed.

The lower limestone sections' deterioration was caused by completely inappropriate interventions. The soft Indiana Limestone was pressure washed forcing water into the porous stone, which in turn caused the efflorescence present on the exterior of the building face.

Also the pressure washing removed the protective patina on the stone, causing spauling. The wand marks from the pressure washing are still clearly visible. This intervention was supposedly done to remove graffiti but instead has caused substantial damage.
